PHASE I

SITE ASSESSMENT

Site Identification: 3095 Albany Post Road
Village of Buchanan
Town of Cortlandt
Westchester County, New York

WCD File: AB18113.10

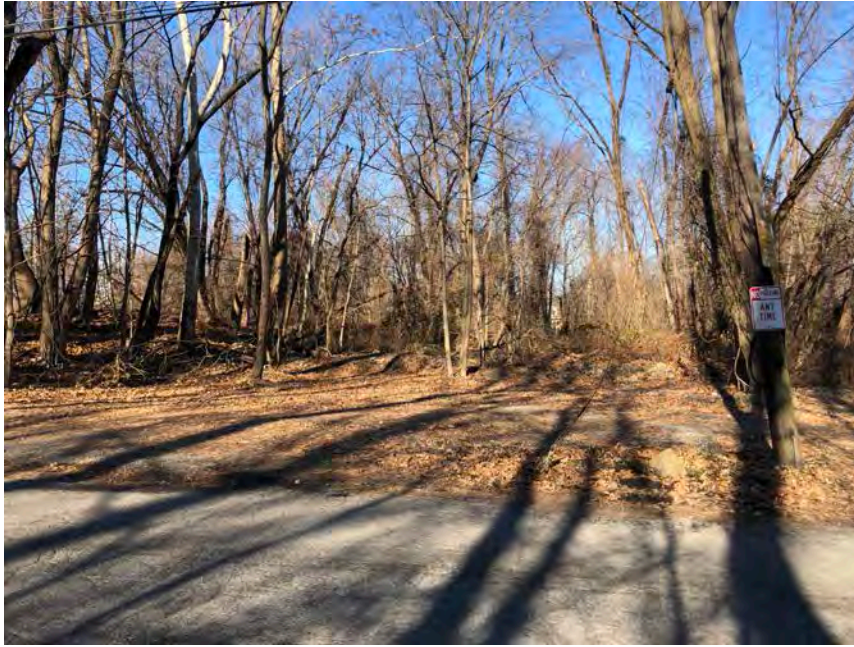
1. Subject property, looking north from Lake Street

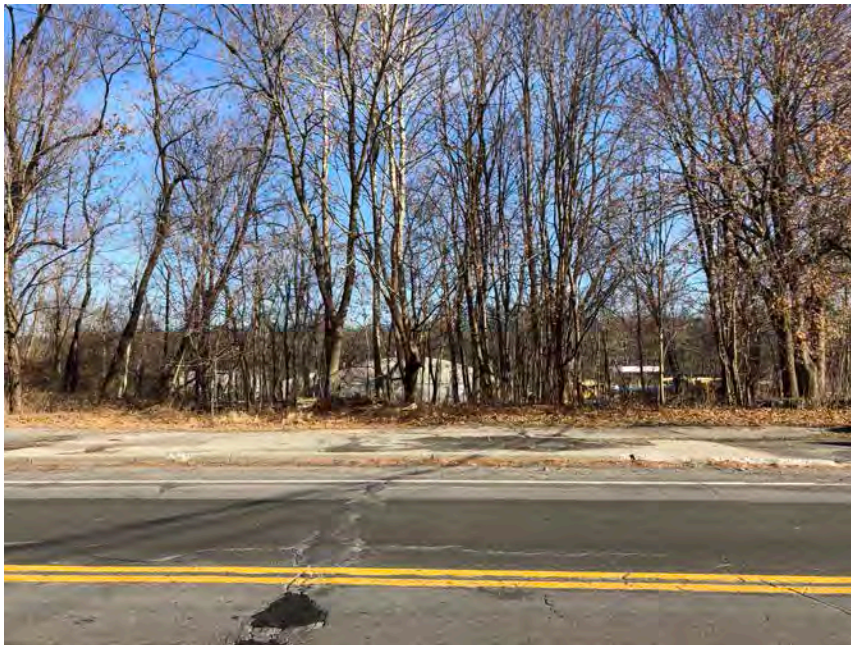
No structures are present on the subject property. A concrete surface (likely foundation remains from former filling station and automotive repair facility) was observed at the southwestern corner of the

2. Concrete surface at southwestern corner of property (likely foundation remains from former filling station and automotive repair facility)

Category	Specific Environmental Concerns	Recommendations
RECs *	Potential impacts from former commercial use of the subject property, including automotive repair activities and a filling station	A subsurface investigation should be conducted to document site conditions
General Environmental Concerns	Potential subsurface demolition debris; presence of former filling station at adjoining property to the northwest (current automotive repair facility).	Properly manage any materials encountered during site development/use; investigate potential impacts from adjoining repair facility based on planned use of the northwestern portion of the subject property
Non-Scope Considerations	On-site debris (including materials potentially containing asbestos or lead)	Dispose off-site, in accordance with any applicable local, state and federal regulations

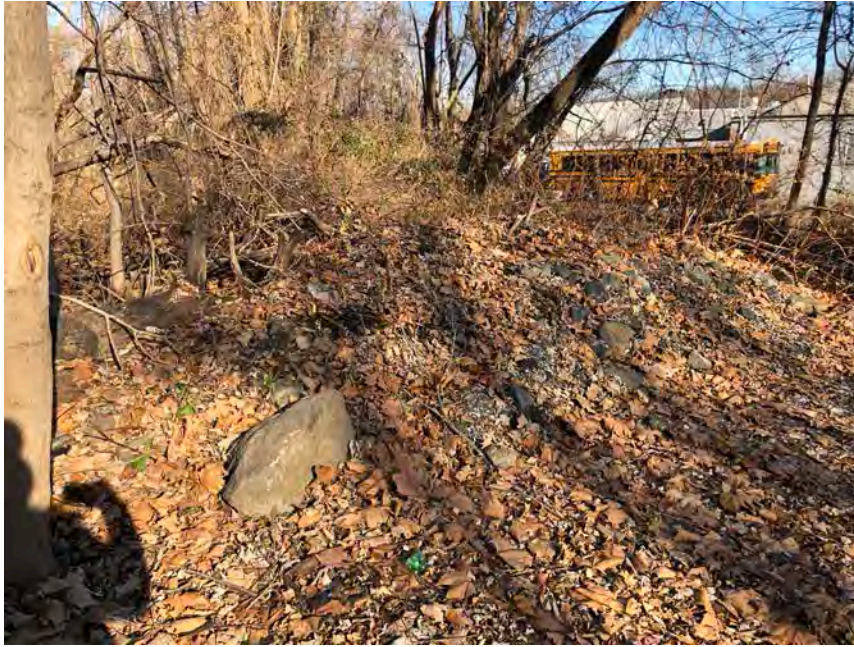
3. Area of debris, southeastern portion of property

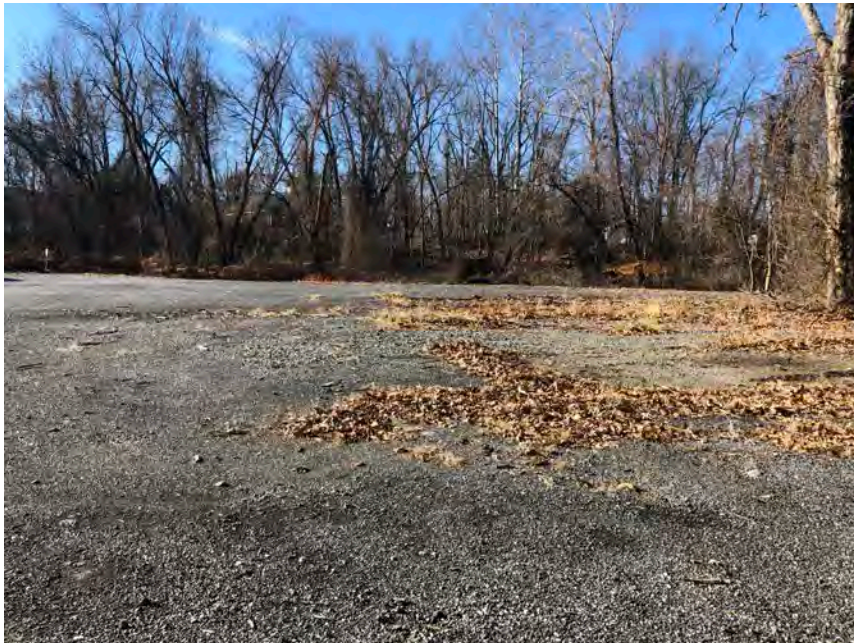
4. Gravel area, eastern-central portion of property

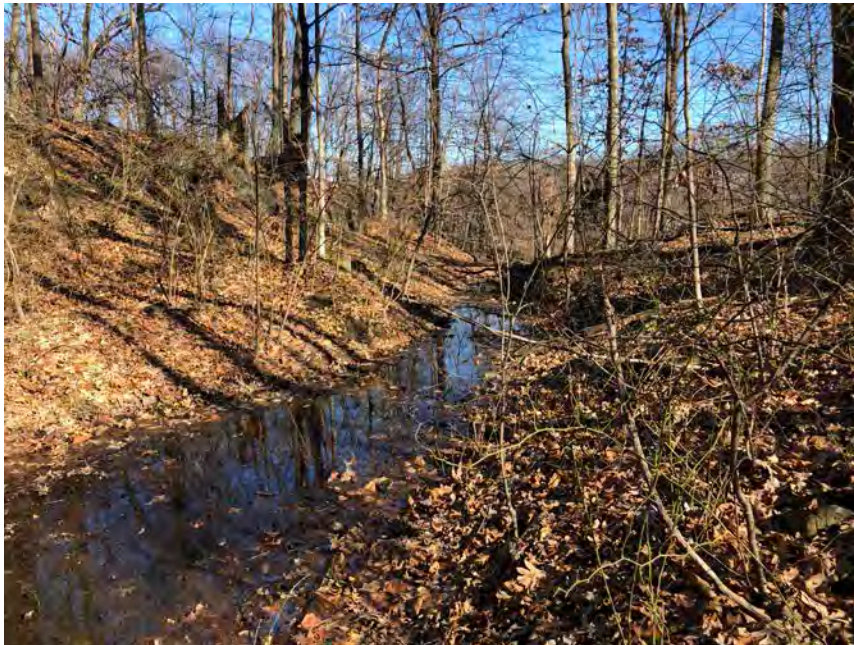
A stream was observed at the eastern-central portion of the property, flowing into the pond to the northeast. Several areas of standing water were present throughout the eastern portion of the property.

6. Stream, eastern-central portion of property
